Advisory No.: SER01420

Title: H10 Crane ATB

Product Series /Model: H10025 & H10034 Cranes

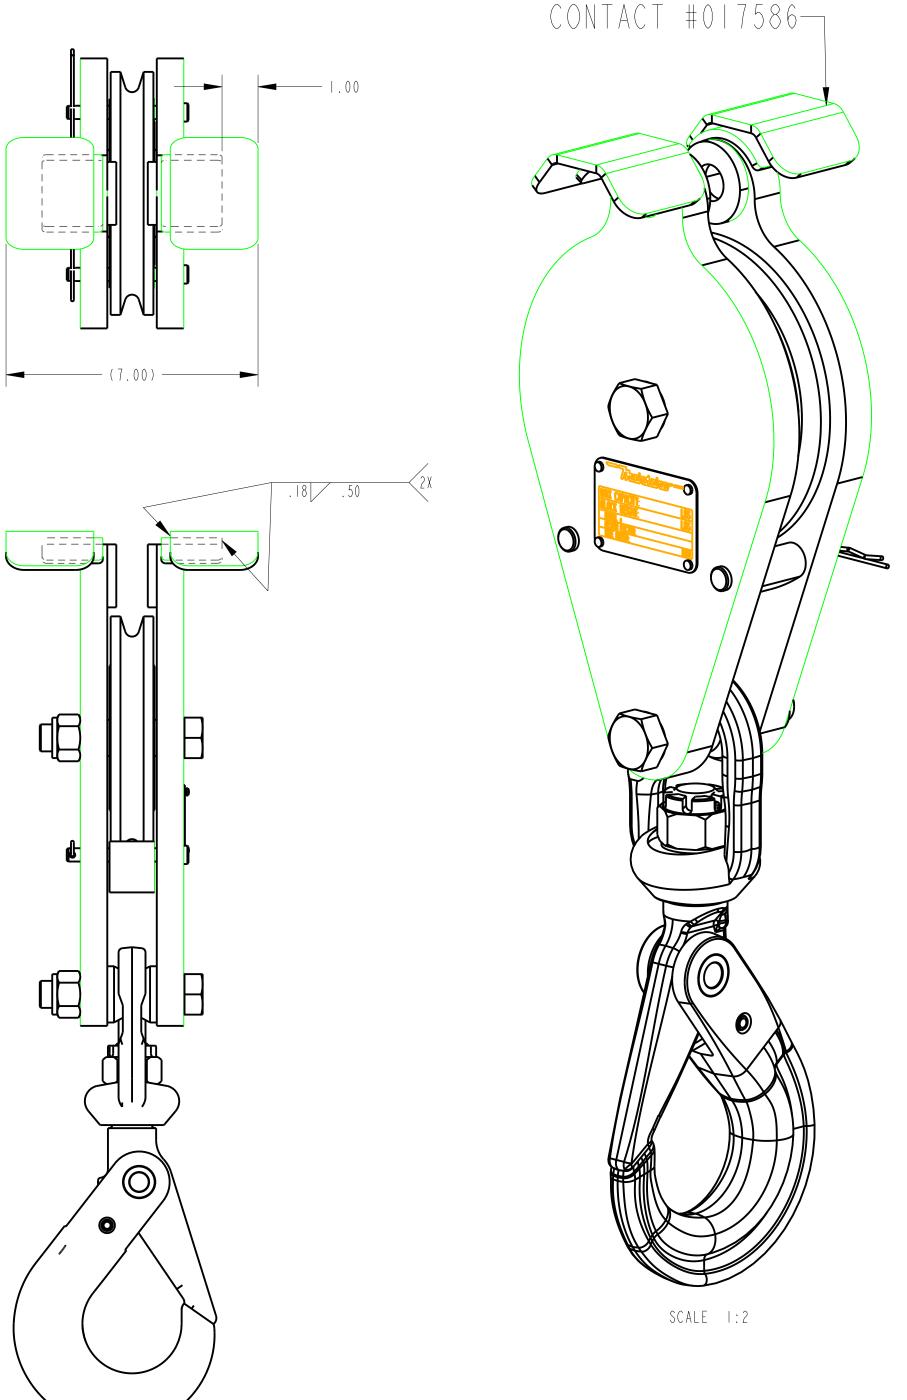
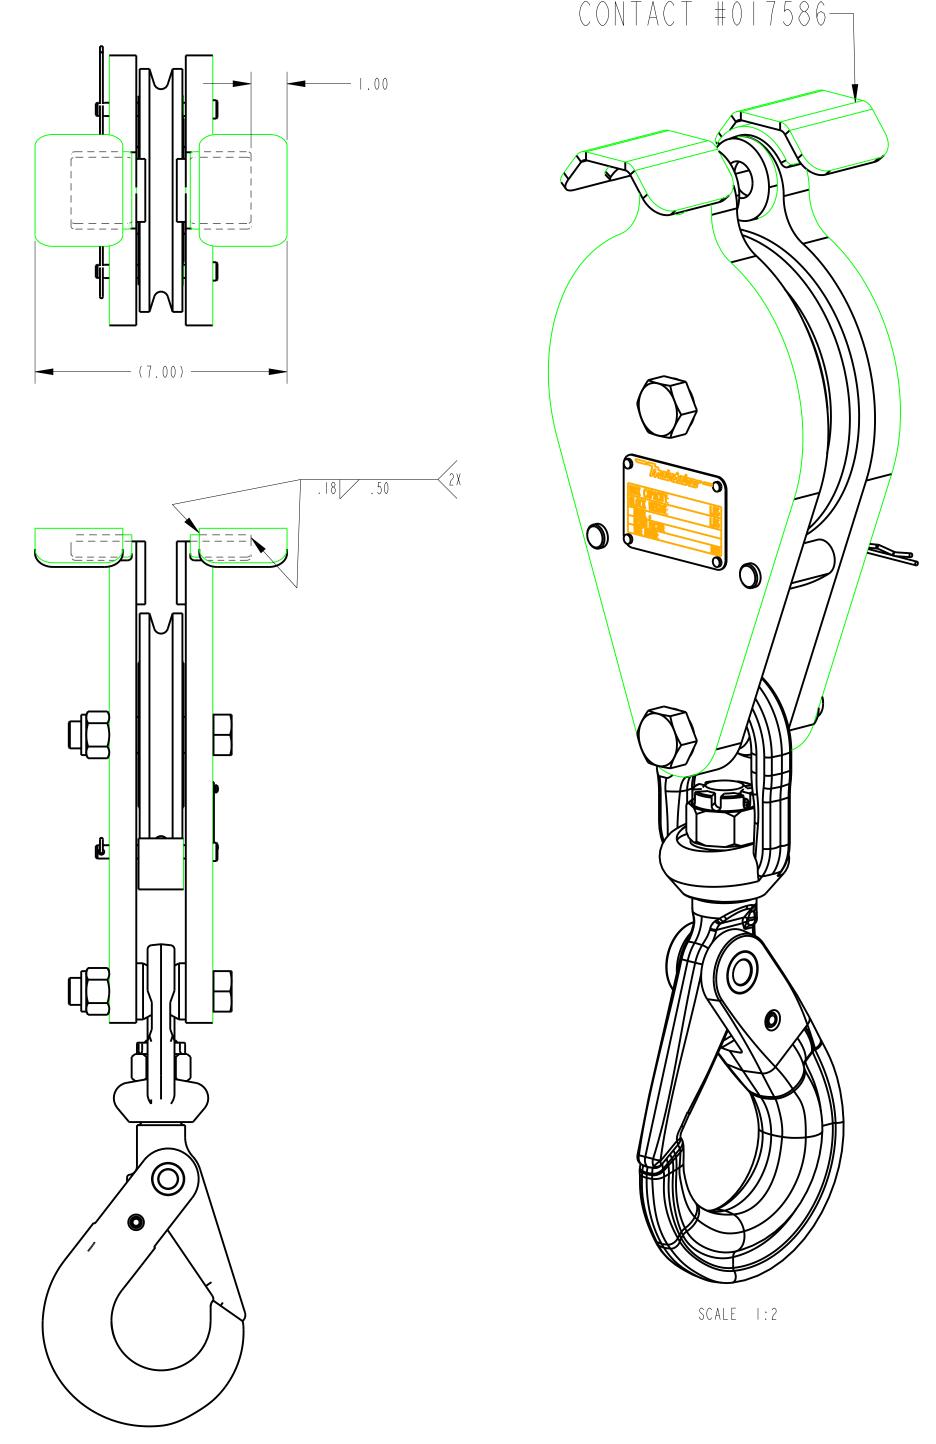
# STEP 5 Ο $\bigcirc$ $\bigcirc$ **A** 0 0 —ADJUSTMENT BOLT

The anti-2-block system has been noted at certain angles, running full speed, with no load, that the load block can travel up and around the anti-2-block arm, which may allow 2-blocking.

ADJUST A2B SWITCH:

- ANTI-2-BLOCK SWITCH IS TO BE WIRED "NORMALLY OPEN"
- ANTI-2-BLOCK SWITCH IS SET BY LOOSENING 2) THE UPPER 1/4" BOLT AND REPOSITIONING THE SWITCH & COVER TOGETHER
- MOVING THE SWITCH AND COVER AWAY 3) FROM THE CONTACT ON THE ARM WILL MAKE THE SWITCH ACTIVATE EARLIER
- THE SWITCH SHOULD TRIP AT ~3/8" 4) OF TRAVEL AT THE FRONT END OF THE ANTI-2-BLOCK ARM
